**Flood Control Project Maintenance
Levee Inspections**

2011 Channel Summary Report

Madera County FCWCA

Flood Control Project Maintenance**Unit Cover Sheet****2011 Channel Inspection Results****Madera County FCWCA**

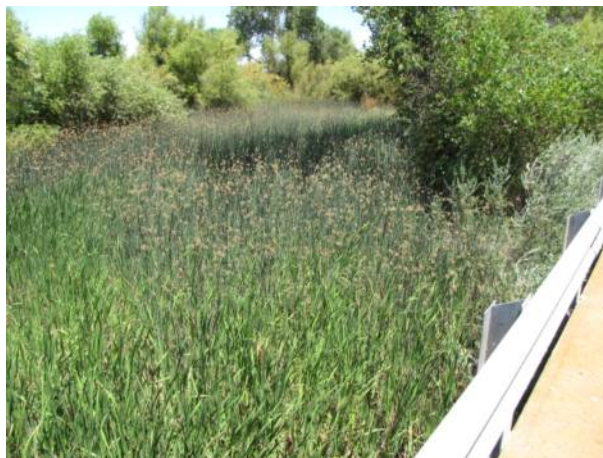
Levee Mile Report Line	11
Start Levee Mile	0.00
End Levee Mile	0.00
Location	
Category	Channels
Item	Vegetation & Obstructions

Avenue 26 bridge crossing looking upstream there is unsatisfactory growth of tulies in channel. Photo taken 7-21-2011.

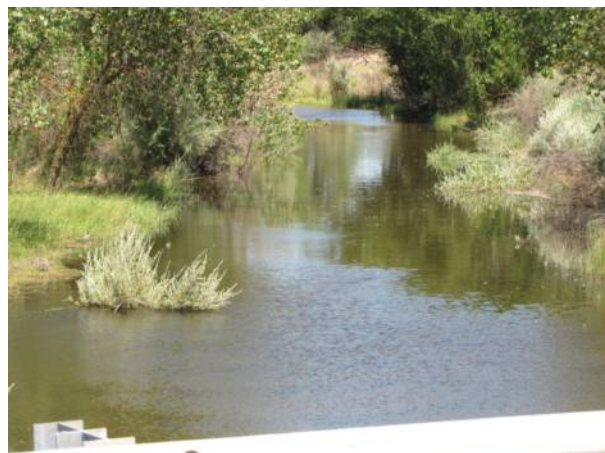
From Chowchilla Blvd. Crossing looking upstream flow is moving freely. Photo taken 7-20-2011.

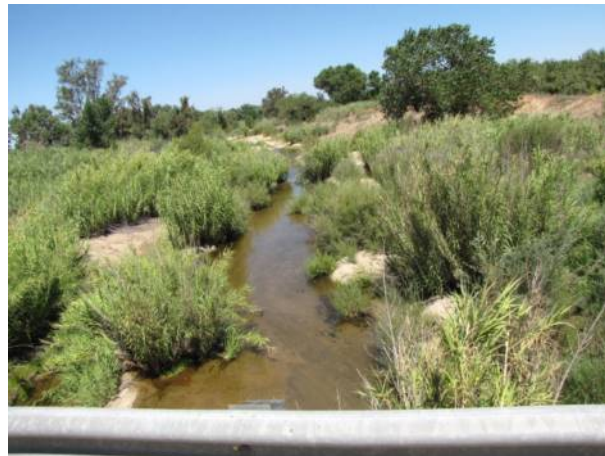
Levee Mile Report Line	41
Start Levee Mile	0.00
End Levee Mile	0.00
Location	
Category	Channels
Item	Vegetation & Obstructions

Standing on Road 16 looking upstream at Berenda Slough wild growth in channel. Photo taken 7-20-2011.

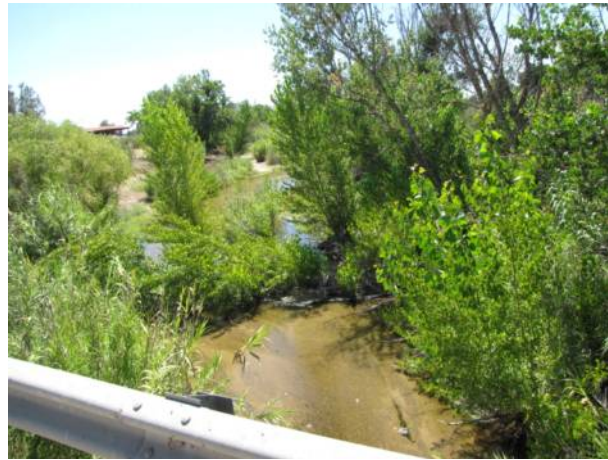
Looking downstream from Rd 16 bridge crossing Berenda Slough, wild growth in channel. Photo taken 7-20-2011.

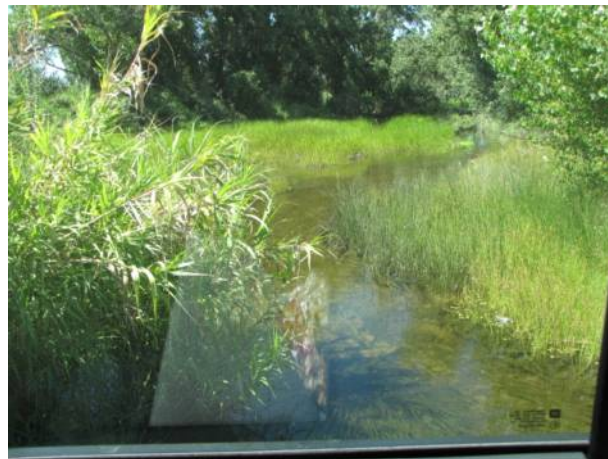
Levee Mile Report Line	51
Start Levee Mile	0.00
End Levee Mile	0.00
Location	
Category	Channels
Item	Vegetation & Obstructions

From Ave 22 1/2 looking upstream at Berenda Slough growth in channel flow not completely blocked. Photo taken 7-20-2011

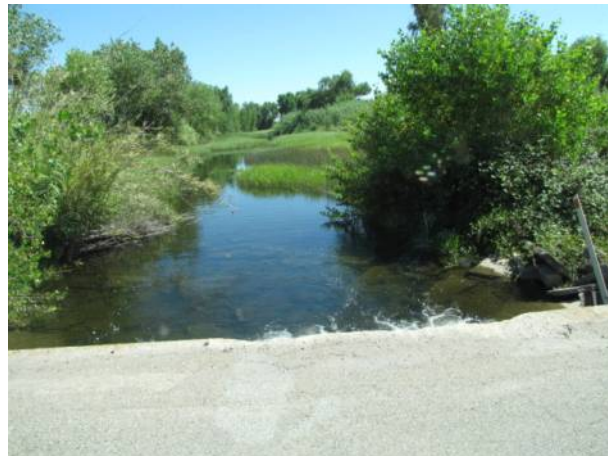
Levee Mile Report Line	56
Start Levee Mile	0.00
End Levee Mile	0.00
Location	
Category	Channels
Item	Vegetation & Obstructions

Looking downstream from Ave. 22 1/2 at Berenda Slough wild growth present in channel, bamboo, willow trees, aquatic plantings and etc. This photo was taken 7-20-2011.

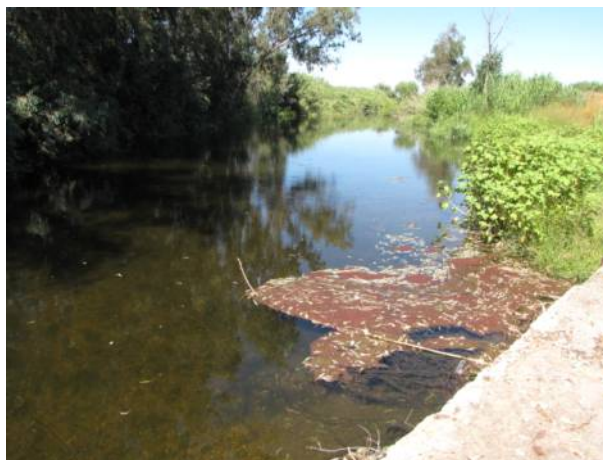
Standing on low water crossing (Ave. 22) looking upstream at Berenda Slough. Some vegetation visible on right bank, flow moves freely. Photo taken 7-20-2011.

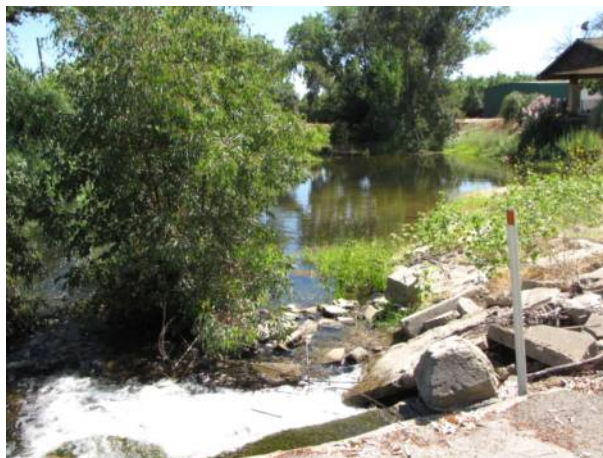
Levee Mile Report Line	66
Start Levee Mile	0.00
End Levee Mile	0.00
Location	
Category	Channels
Item	Vegetation & Obstructions

Standing on Ave. 22 (lowwater crossing) looking downstream at Berenda Slough, this crossing has culverts in place for water to travel through. Photo taken 7-20-2011.

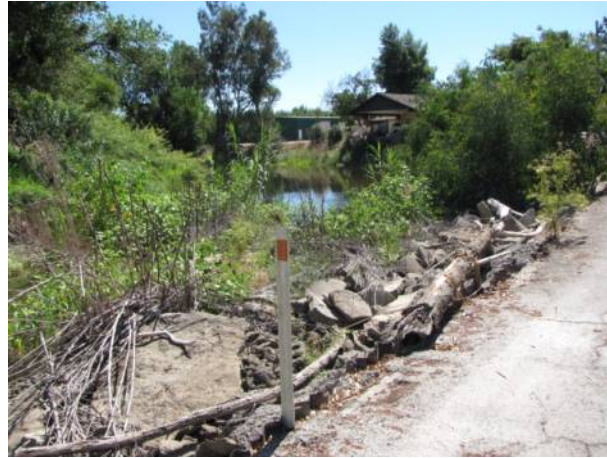
Downstream of Ave 22 build up of driftwood, rock and other materials are present at this site.

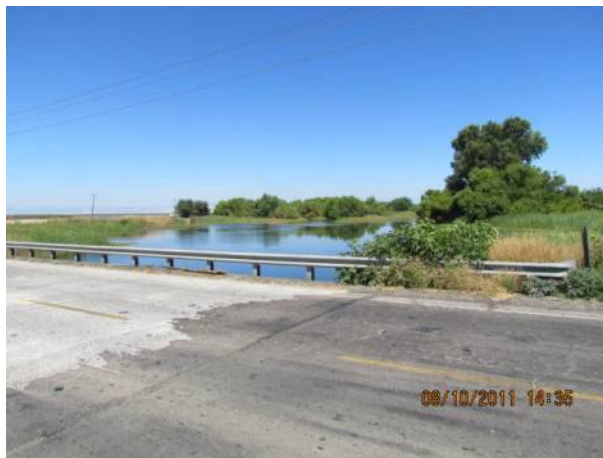
Levee Mile Report Line	41
Start Levee Mile	
End Levee Mile	
Location	
Category	Channels
Item	Vegetation & Obstructions
Looking upstream from Road 15	
richard_c_20110831_007.jpg

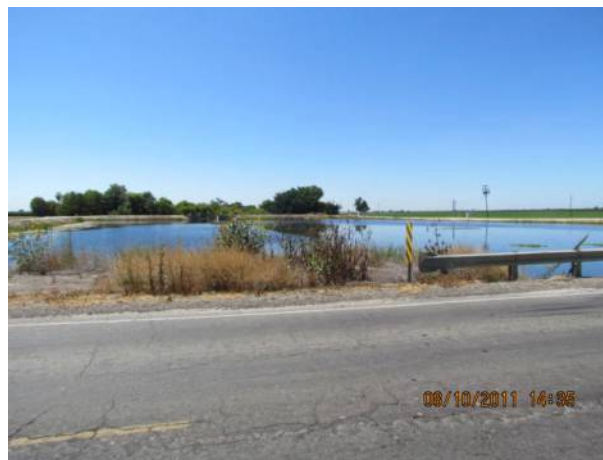
Levee Mile Report Line	46
Start Levee Mile	
End Levee Mile	
Location	
Category	Channels
Item	Vegetation & Obstructions

Looking downstream at Check Dam from Road 15

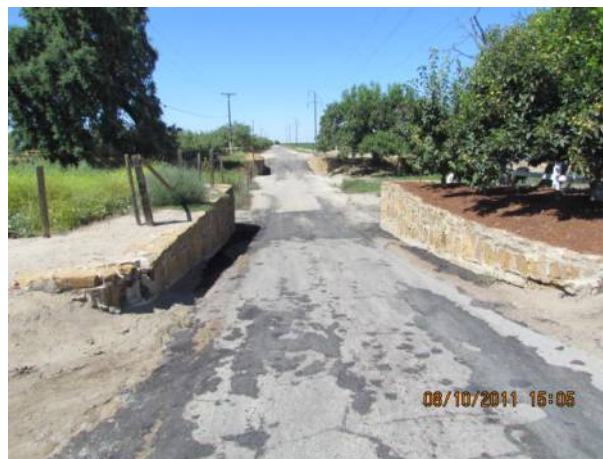
Levee Mile Report Line	51
Start Levee Mile	
End Levee Mile	
Location	
Category	Channels
Item	Vegetation & Obstructions

Looking north at low water-crossing at Road 11

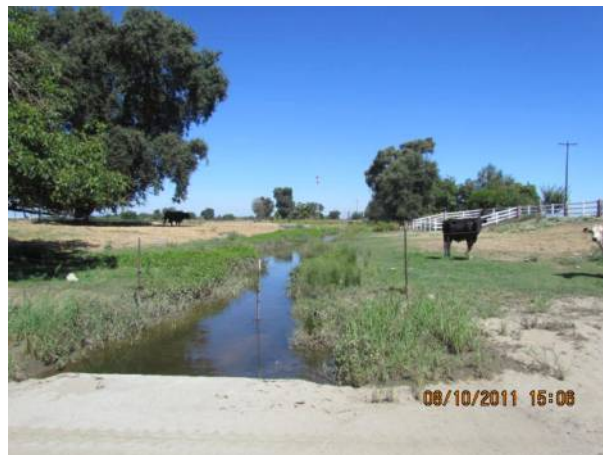
Levee Mile Report Line	51
Start Levee Mile	
End Levee Mile	
Location	
Category	Channels
Item	Vegetation & Obstructions

Looking upstream from Road 11

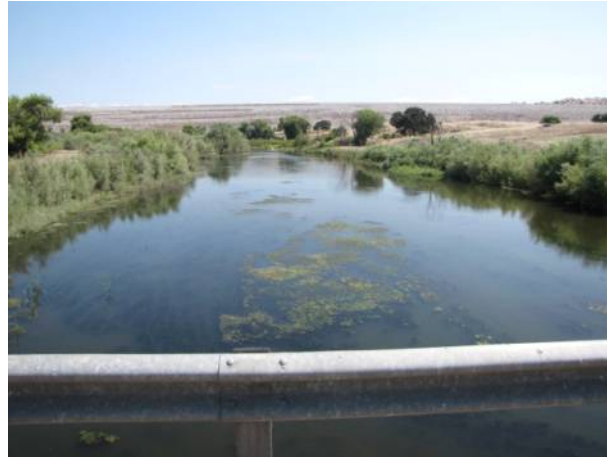
Looking upstream of Fresno River at Hidden Dam in background. Photo taken 7-14-2011

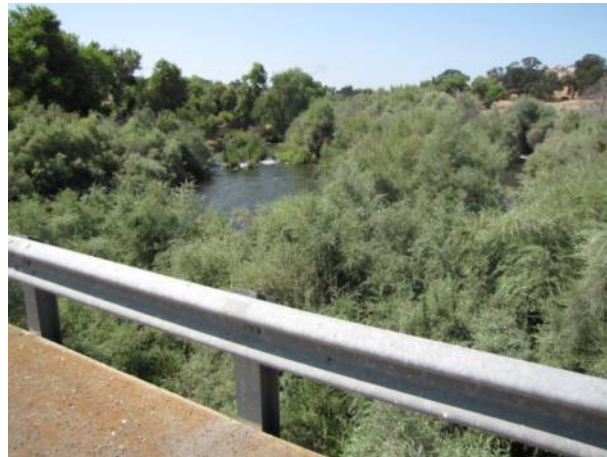
Levee Mile Report Line	6
Start Levee Mile	0.00
End Levee Mile	0.00
Location	
Category	Channels
Item	Vegetation & Obstructions

Looking downstream from bridge crossing of the Fresno River unsatisfactory growth in channel. This photo was taken 7-14-2011.

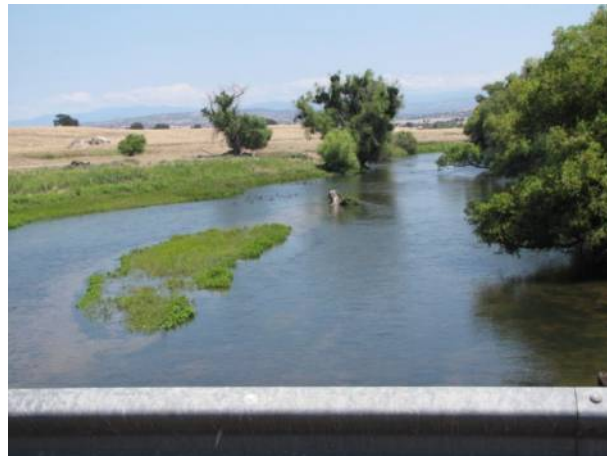
Levee Mile Report Line	11
Start Levee Mile	0.00
End Levee Mile	0.00
Location	
Category	Channels
Item	Vegetation & Obstructions

Standing on wooden bridge crossing the Fresno River looking upstream. Photo taken 7-14-2011.

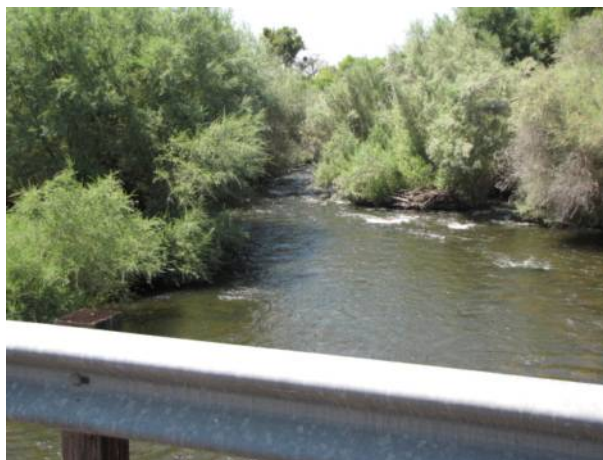
Looking downstream from timber bridge crossing the Fresno River. Photo taken 7-14-2011.

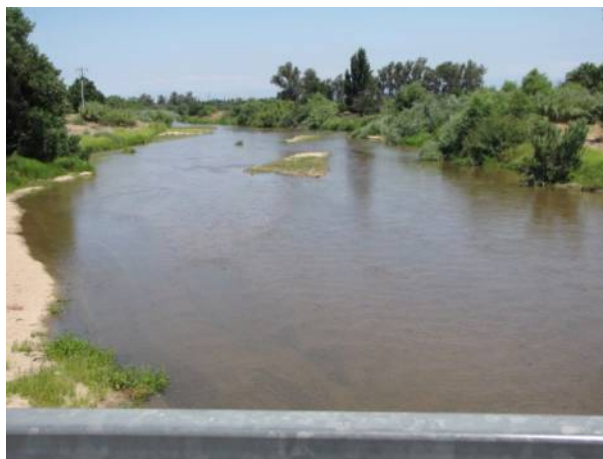
Levee Mile Report Line	21
Start Levee Mile	0.00
End Levee Mile	0.00
Location	
Category	Channels
Item	Vegetation & Obstructions

Standing on Cleveland Ave. road crossing looking upstream at Fresno River crossing. Photo taken 7-14-2011.

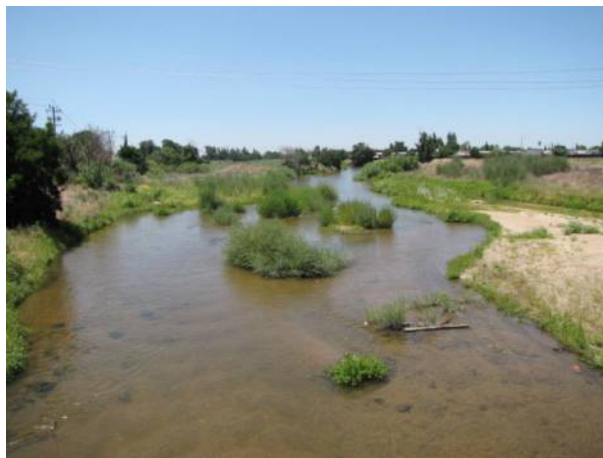
Levee Mile Report Line	26
Start Levee Mile	0.00
End Levee Mile	0.00
Location	
Category	Channels
Item	Vegetation & Obstructions

Looking downstream at Fresno River from Cleveland Avenue road crossing. Photo taken 7-14-2011.

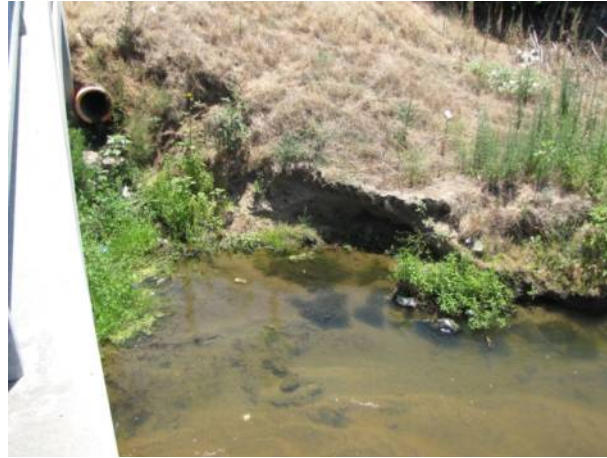
Levee Mile Report Line	28
Start Levee Mile	0.00
End Levee Mile	0.00
Location	
Category	Channels
Item	Erosion / Bank Caving
Looking downstream L/B at erosion bridge. Photo taken 7-14-2011.	
phillips_c_20110801_049.jpg

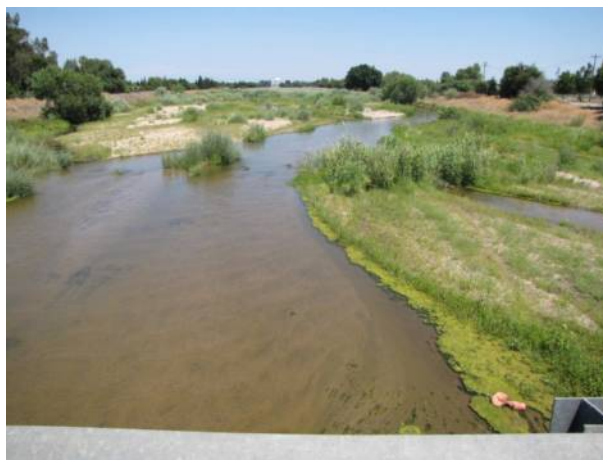
Upstream of Granada Avenue crossing the Fresno River. Photo taken 7-14-2011.

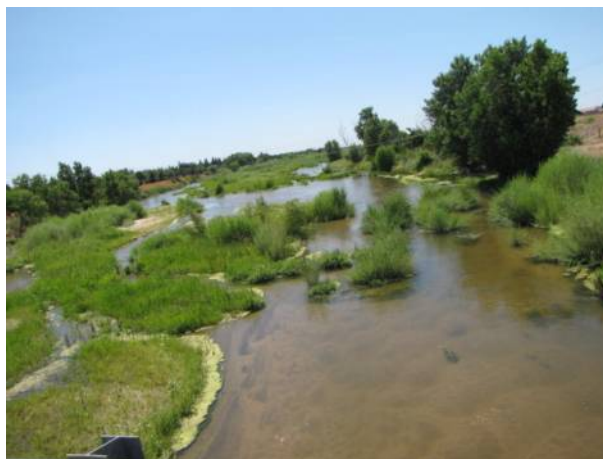
Levee Mile Report Line	46
Start Levee Mile	0.00
End Levee Mile	0.00
Location	
Category	Channels
Item	Vegetation & Obstructions

Granada Ave. road crossing the Fresno River looking downstream. Photo taken 7-14-2011.

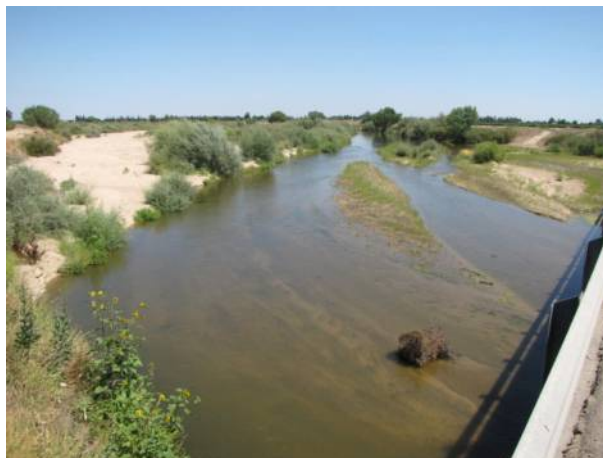
Levee Mile Report Line	51
Start Levee Mile	0.00
End Levee Mile	0.00
Location	
Category	Channels
Item	Vegetation & Obstructions

Road 23 crossing Fresno River looking upstream. Photo taken 7-14-2011.

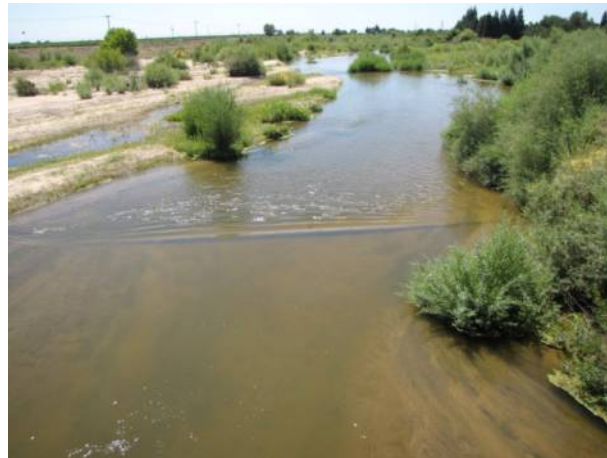
Rd 23 crossing the Fresno River looking downstream. Photo taken 7-14-2011.

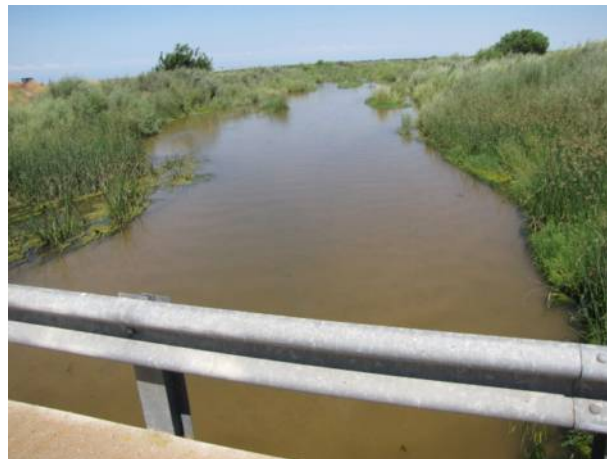
Levee Mile Report Line	61
Start Levee Mile	0.00
End Levee Mile	0.00
Location	
Category	Channels
Item	Vegetation & Obstructions

Rd 20 bridge crossing the Fresno River looking upstream. Photo taken 7-14-2011.

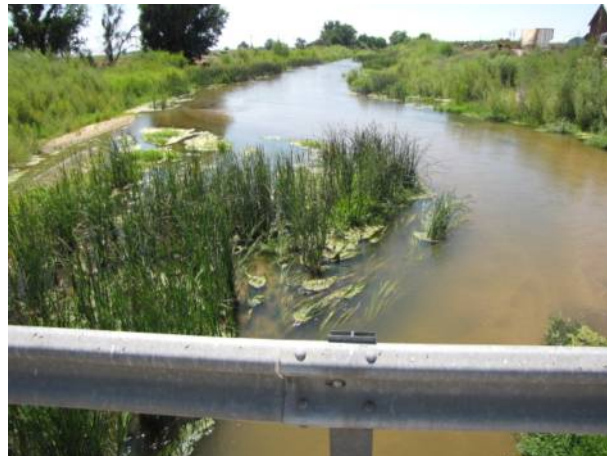
Levee Mile Report Line	66
Start Levee Mile	0.00
End Levee Mile	0.00
Location	
Category	Channels
Item	Vegetation & Obstructions

Rd 20 bridge crossing the Fresno River looking downstream. Photo taken 7-14-2011.

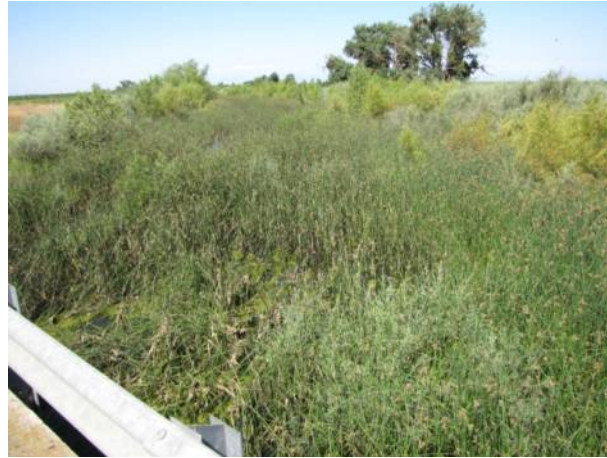
Rd 19 D/S Limits bridge crossing the Fresno River, channel completely covered in tullies. Unable to see channel. Photo taken 7-14-2011.

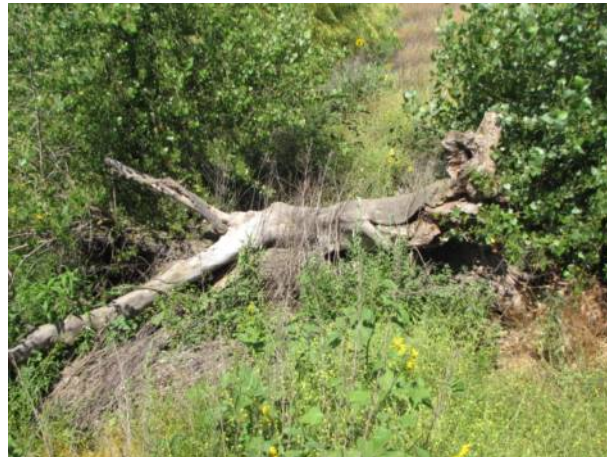
Levee Mile Report Line	75
Start Levee Mile	0.00
End Levee Mile	0.00
Location	
Category	Channels
Item	Encroachments

This dead tree is located at the bridge in channel.

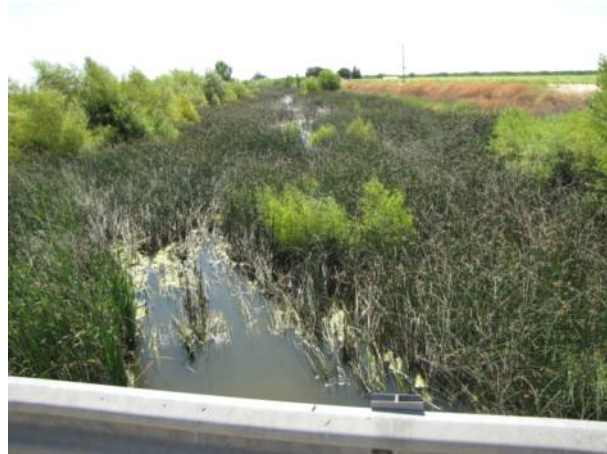
Levee Mile Report Line	76
Start Levee Mile	0.00
End Levee Mile	0.00
Location	
Category	Channels
Item	Vegetation & Obstructions

Rd 19, D/S Limits bridge crossing the Fresno River looking downstream. Wild growth of tullies and willows in channel. Photo taken 7-14-2011.
